GROUNDWATER INVESTIGATION REPORT

**Cometco Corporation
1509 West Cortland Street
Chicago, Illinois 60622
LPC #0316005505**

**Metal Management Midwest, Inc.
12701 South Doty Avenue
Chicago, IL 60633**

**CPI Environmental Services, Inc.
799 Roosevelt Road
Building 6, Suite 110
Glen Ellyn, Illinois 60137**

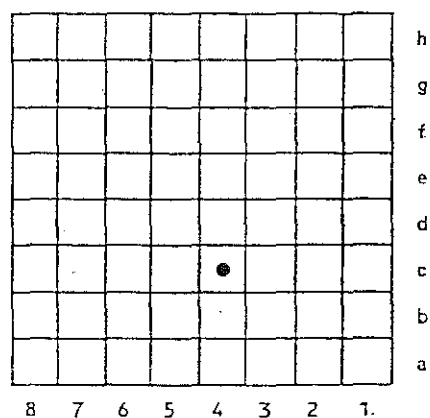
The location of the well shown above is 163 2N10W-23.4c. The well point is located at the center of this 10-acre plot.
